XLI. *An Account of the Effects of Lightning in St. Bride's Church, Fleet-street, on the 18th of June 1764: In a Letter to Mr. Benjamin Wilſon, F. R. S. from Edward Delaval Eſq; F. R. S.*

Read June 28, 1764. **T**HE incloſed is an account of the effects of the lightning on the ſteeple and ſpire of St. Bride's church, with drawings [TAB. XIV. XV.] which very accurately expreſs the parts damaged by it.

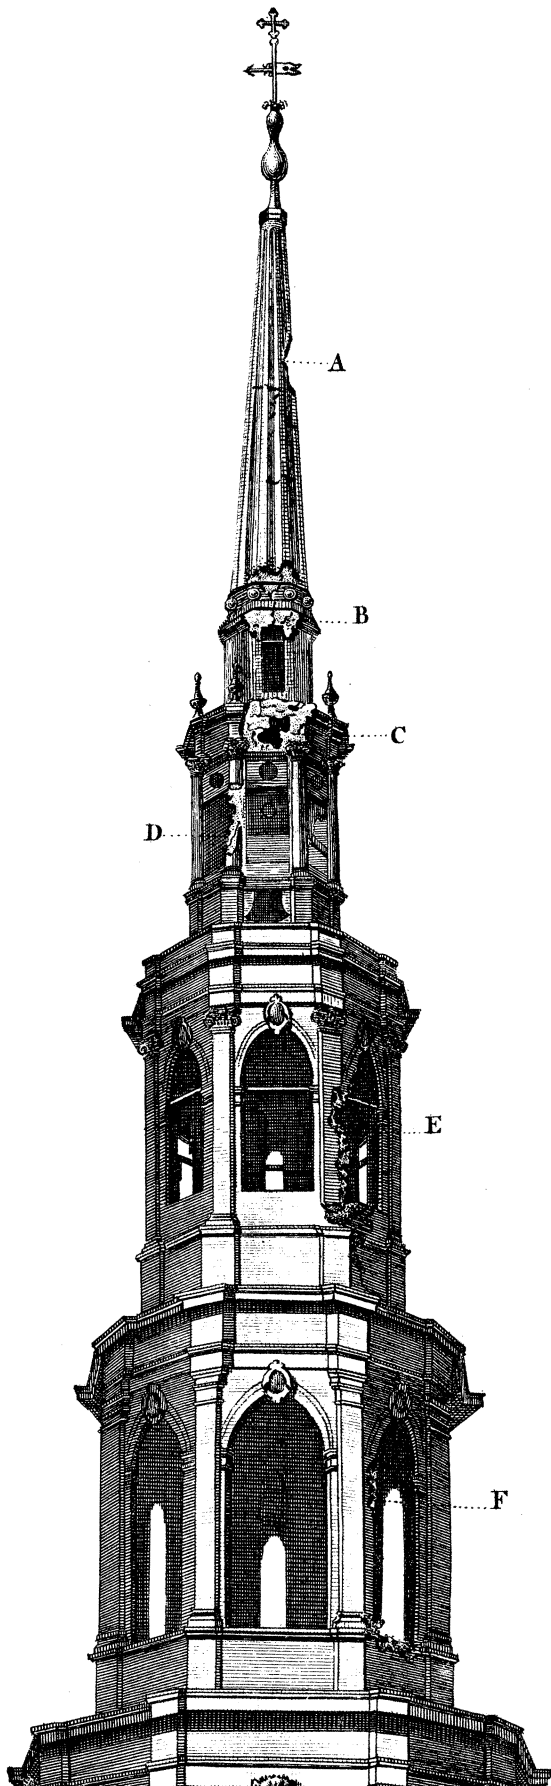
At this place the first marks of it are seen: at H the top of the copper cross, which is the highest part of the building, the gilding is by the explosion partly torn off and partly discoloured, so as to differ remarkably from the rest of the cross where the gilding is very well preserved. Some small pieces of solder are melted; and all this part appears as if it had been exposed to the fire.

The lightning seems to have entered here, and to have been conducted as low as the hole at A, by an iron spindle twenty feet in length, and two inches in diameter; of which ten feet were surrounded by the copper ball, vane and cross; and the lower half was inclosed in a groove cut through the middle of the solid stones which composed the upper part of the spire, and rested at A on the bottom of that groove, which was sunk five inches deep into the lowest of those solid stones: this last mentioned stone being three feet broad and one deep. The interval between the sides of the spindle and the groove made to receive it was filled up by melted lead poured in between them.

The lightning accumulated in the metal, having its passage towards the earth strongly resisted at this place, has in expanding itself formed the hole A, by
burst-

bursting off from the lower part of the spindle the stones contiguous to it on that side.

At each of the angles of the metal, the stone on which it rested is cracked, which probably was occasioned by the lightning issuing with greater freedom from those parts, than from the flat surface.

From hence, as low as to the corniche B, it seems to have been conducted along the surface of the spire, which was wetted by the rain that had fallen in the morning, before the lightning: and having been accumulated in the iron bars B and C, in discharging itself from them, it has made the greatest explosion at this place.

It is evident that these effects would have been prevented, if a sufficiently large metallic conductor had been extended from the metal at the top of the spire down to the earth, communicating with the other metallic parts of the building that lay in its way.

I think, a conductor of metal less than six or eight inches in breadth, and a quarter of an inch in thickness (or an equal quantity of metal in any other form that may be found more convenient) cannot with safety be depended on, where buildings are exposed to the reception of so great a quantity of lightning. These are the only points in which I have ventured to differ from Dr. Franklyn.

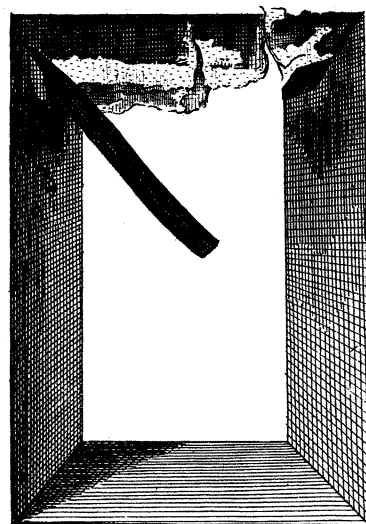
Fig. 2.

At Fig 2, a bar of iron, which served to support the top of the window in the same manner as those last mentioned, 21 inches long clear of the stonework, and half an inch thick, is broke and bent into the position expressed in the drawing; and the stones immediately above it are shattered and disjointed.
