VI. *The Fracture of Metals under Repeated Alternations of Stress.*

By J. A. EWING, LL.D., F.R.S., *Professor of Mechanism and Applied Mechanics in the University of Cambridge*, and J. C. W. HUMFREY, B.A., *St. John's College, Cambridge*, 1851 *Exhibition Research Scholar, University College, Liverpool*.

Received August 11,—Read November 20, 1902.

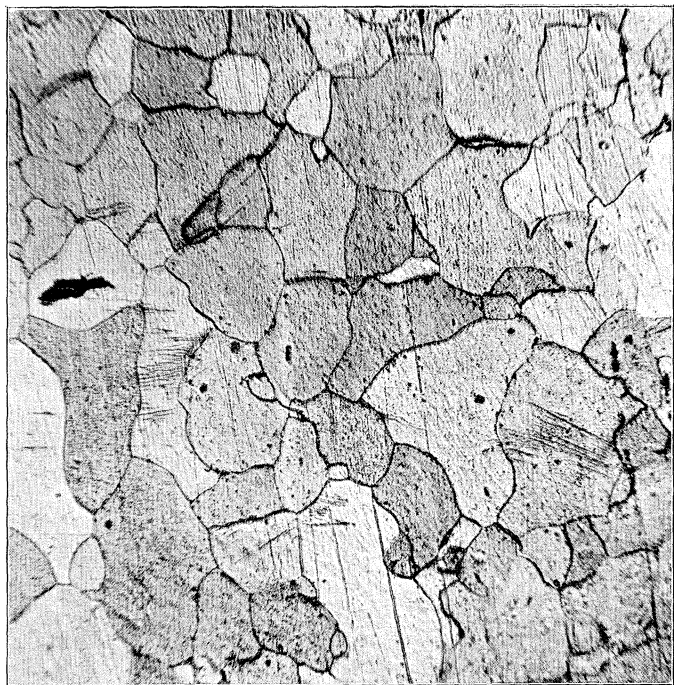
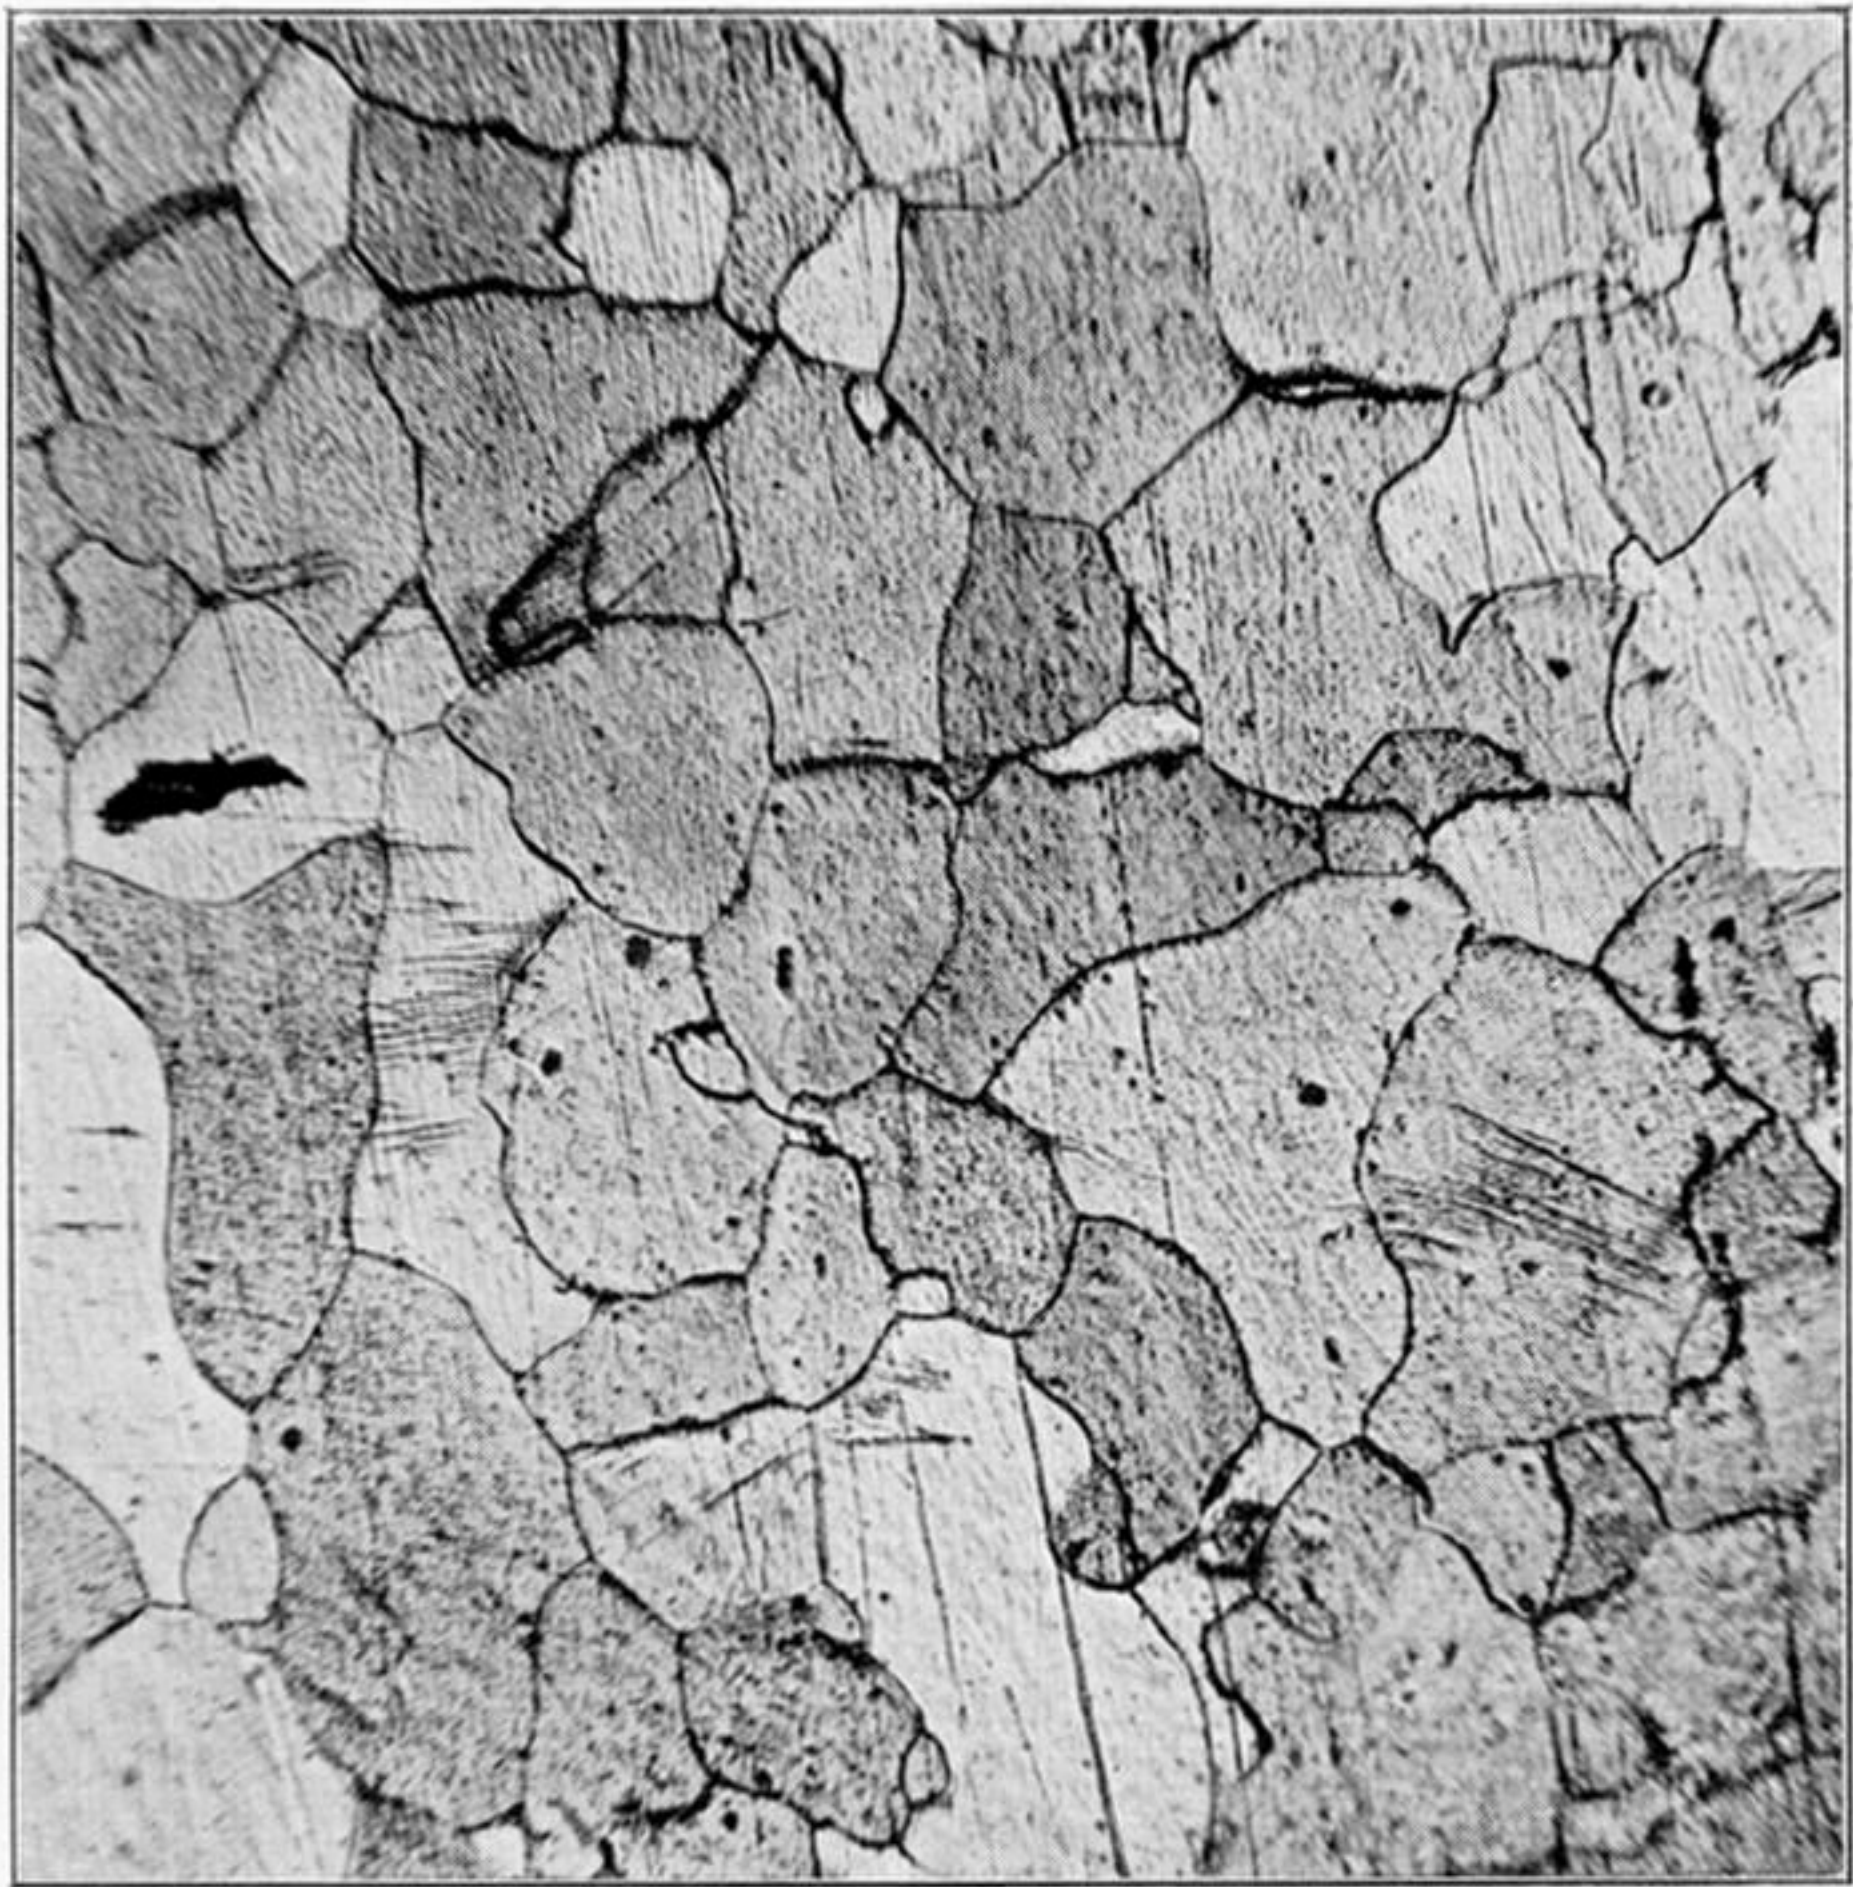
Fig. 3. Specimen of Swedish iron after 5000 reversals of a stress of 14.3 tons per sq. inch. $\times 150$.

The first series show part of a specimen which had been subjected to a stress the maximum value of which, close to the grips, was 14.3 tons per sq. inch. In this series the magnification is 150 diameters. Fig. 3 was taken after 5000 reversals had been given. A few of the crystals exhibit signs of slip, the slip-lines being still fairly fine and sharp. Two crystals in the photograph are seen to have yielded more than the others. Figs. 4 and 5 show the same set of crystals after 40,000 and 60,000 reversals of stress respectively. In fig. 4 a good many more crystals show signs of slip, and the slip-lines which appeared in fig. 3 are far more strongly defined. In some cases it will be seen that the lines have so broadened out as to run together and form dark patches on the surface of the crystals. In fig. 5 a still further breaking up of the surface by slip has occurred. At this stage, and probably earlier, some of the slip-bands have developed into small cracks. Such a crack is seen near the top right-hand corner of the figure, first of all close to a crystalline boundary, and then in steps across the next crystal. On the latter crystal two systems of slip-bands had formed at right angles to one another and at about 45° to the direction of stress. Only one system is clearly visible in the photograph, but it will be seen that the crack runs in steps along both. Fig. 5 shows not only the development of this crack, but also a general increase in width, length, and number of the slip-bands. This was practically the final stage, so far as this portion of the surface was concerned, for the specimen broke after another 10,000 reversals along a crack outside the field of these photographs.

Fig. 3 after 5,000 reversals.

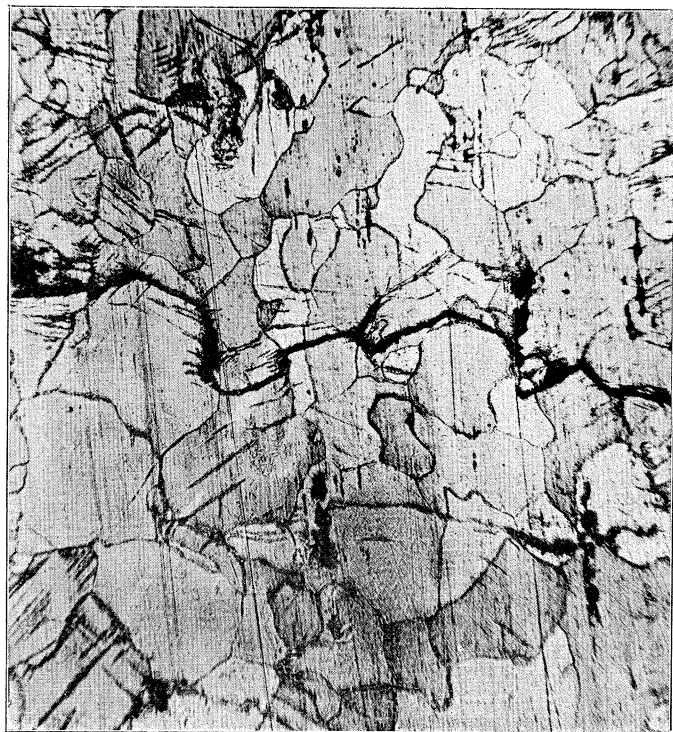
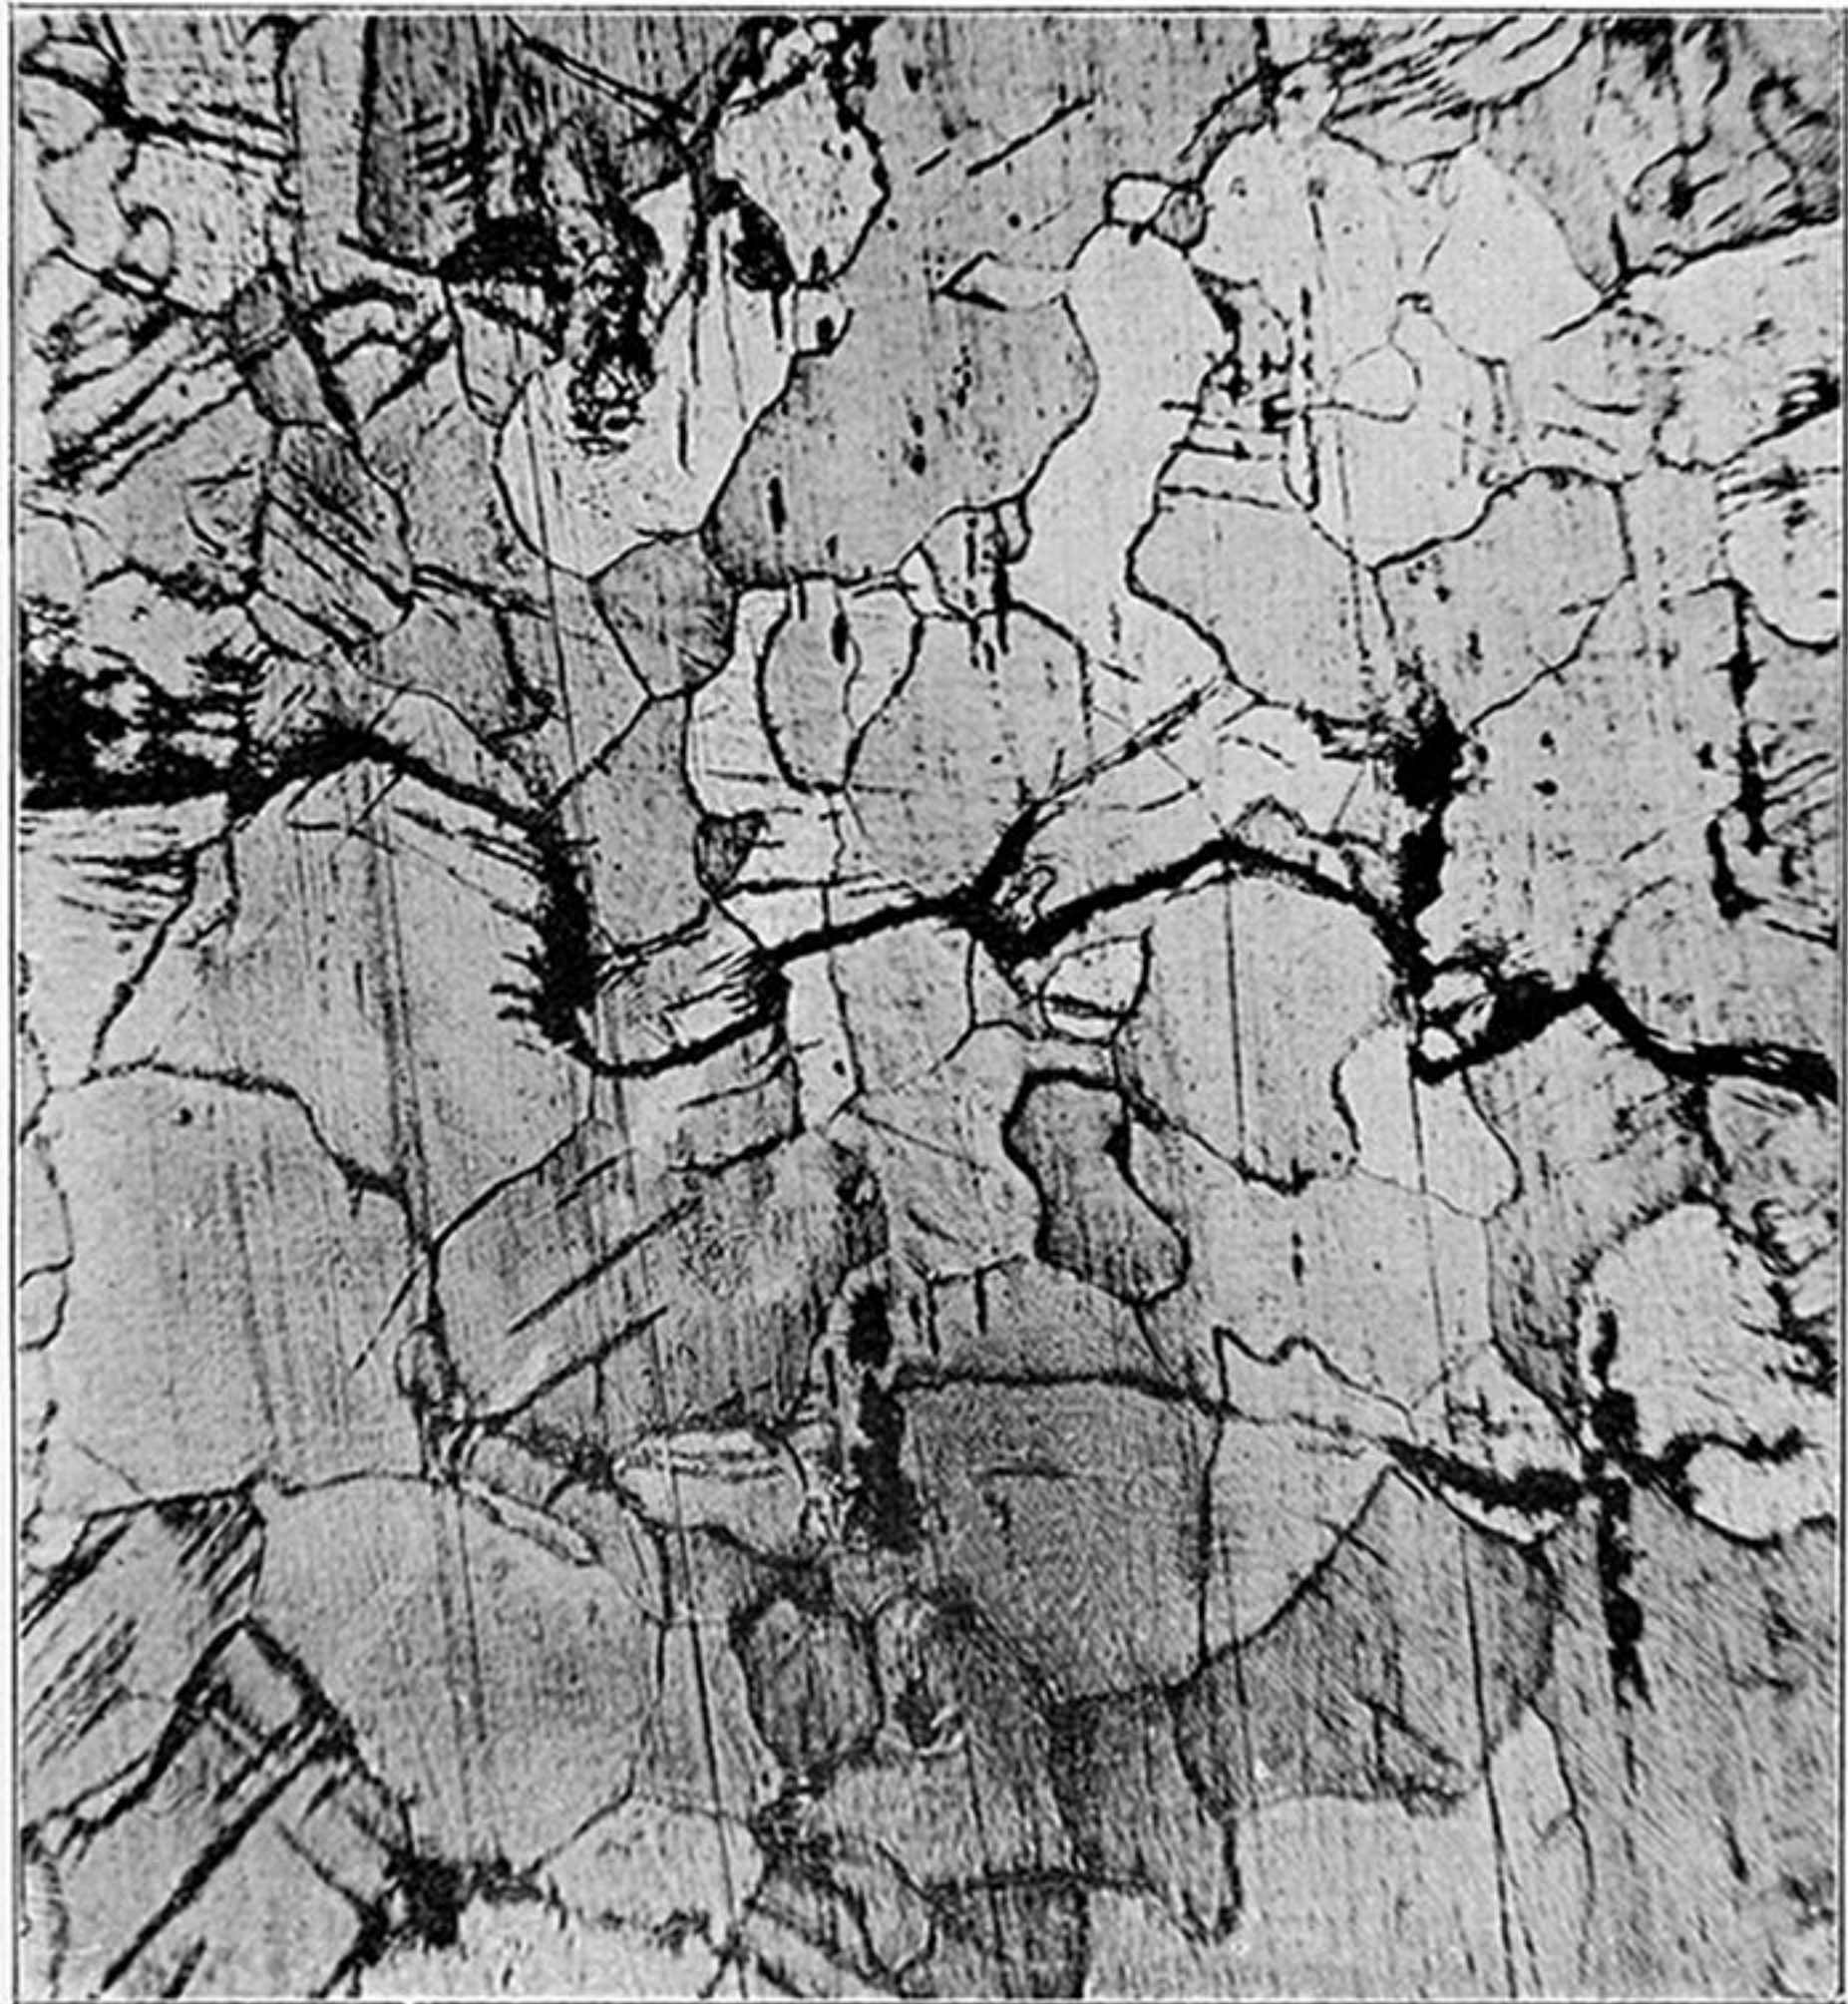
Fig. 7. Specimen after 170,000 reversals of a stress of 12.3 tons per sq. inch. $\times 150$.

The specimen illustrated in the next photograph, fig. 7, had been subjected to

170,000 reversals of a stress of 12.3 tons per sq. inch, at which it broke. The spot shown (magnified 150 diameters) is a little way further from the grips than the crack through which the specimen actually broke, but another severe crack is seen running across the centre of the figure. Comparing this with fig. 5, it will be at once seen that there are far fewer lines due to slip upon each individual crystal than in the former specimen. Fig. 8 shows the same spot after re-polishing and etching. Comparing this with fig. 6 it is seen that a greater proportion of the slip-lines appear in this instance as cracks after re-polishing. The maximum stress is less here than in the former example, and more than twice as many reversals were required to bring about fracture. This agrees with what has been found for all other specimens broken, viz., the lower the stress the fewer the slip-lines upon each crystal, but the greater proportion of these actually develop into cracks under the more numerous reversals to which the less severely stressed specimen is exposed.

Fig. 7 after 170,000 reversals.

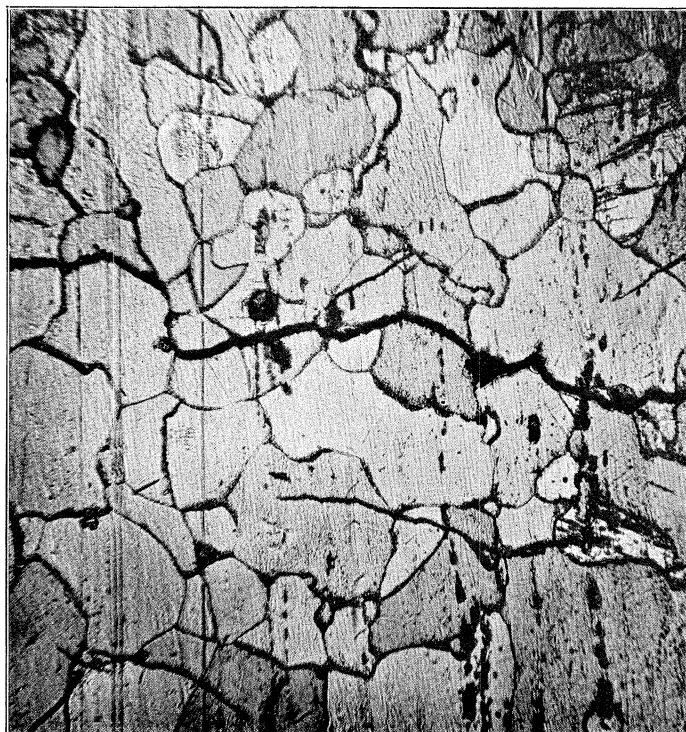
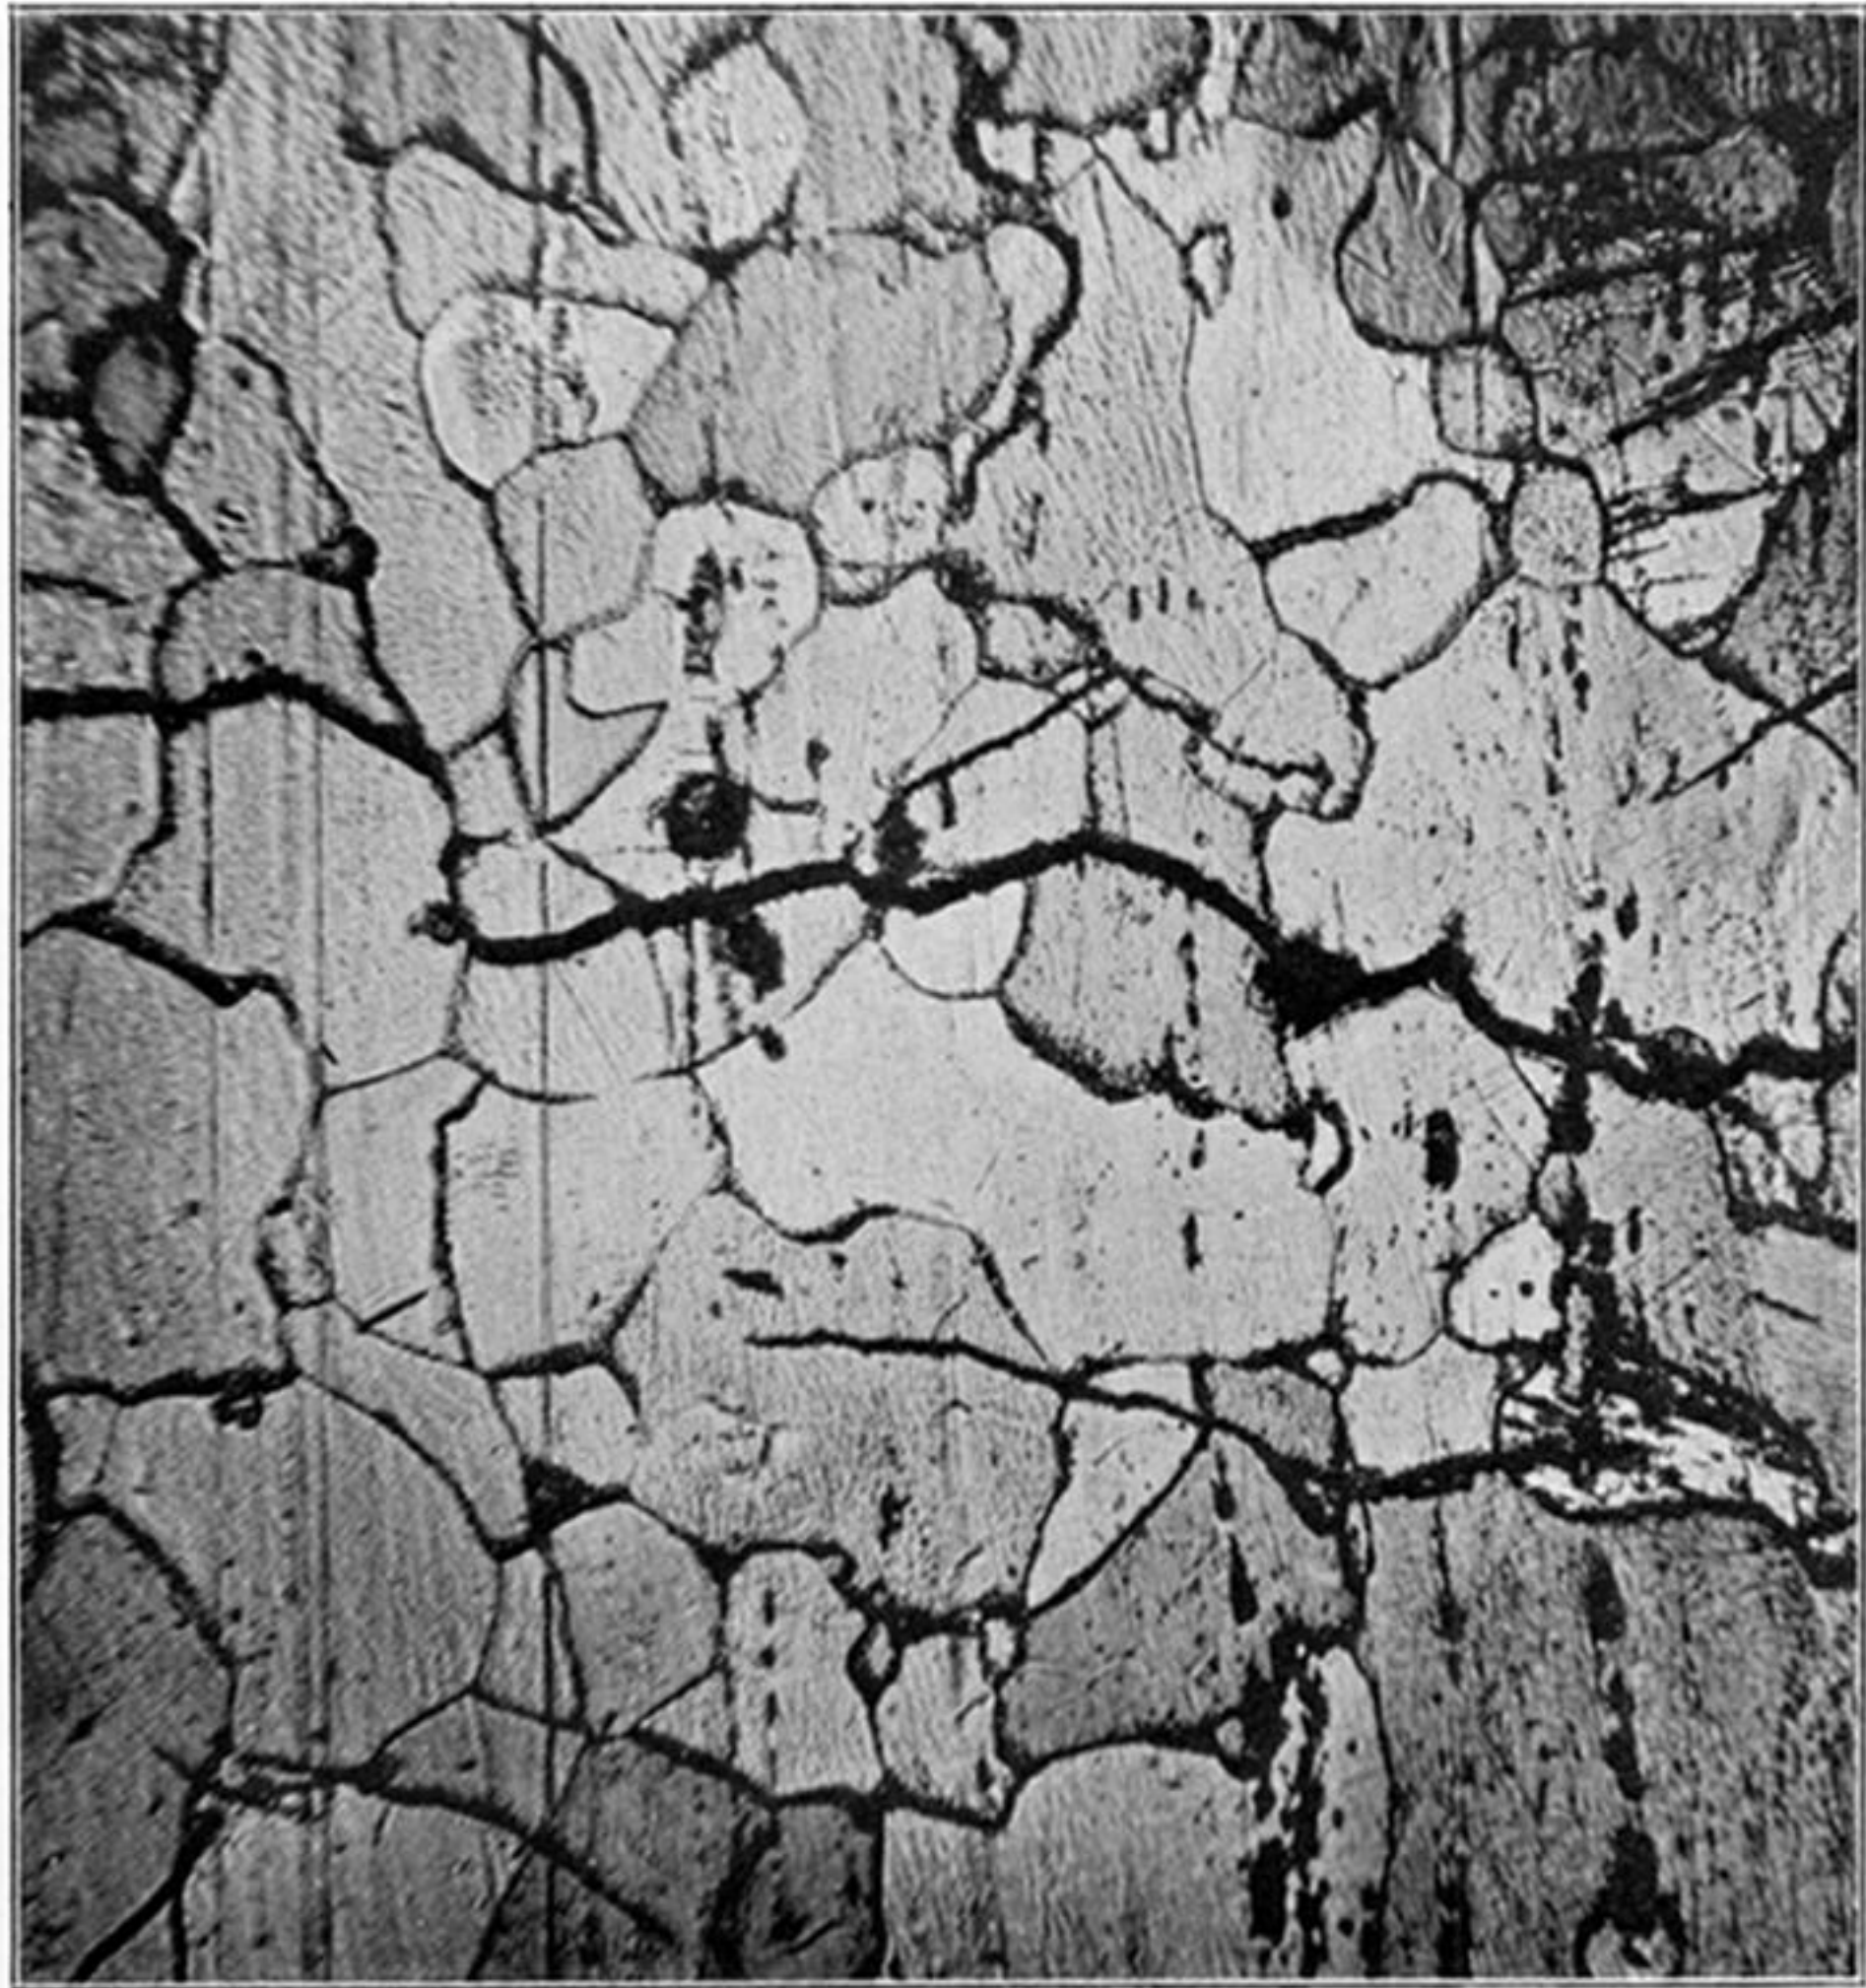
Fig. 8. Same after re-polishing and re-etching. $\times 150$.

Fig. 8 same after re-polishing and re-etching.

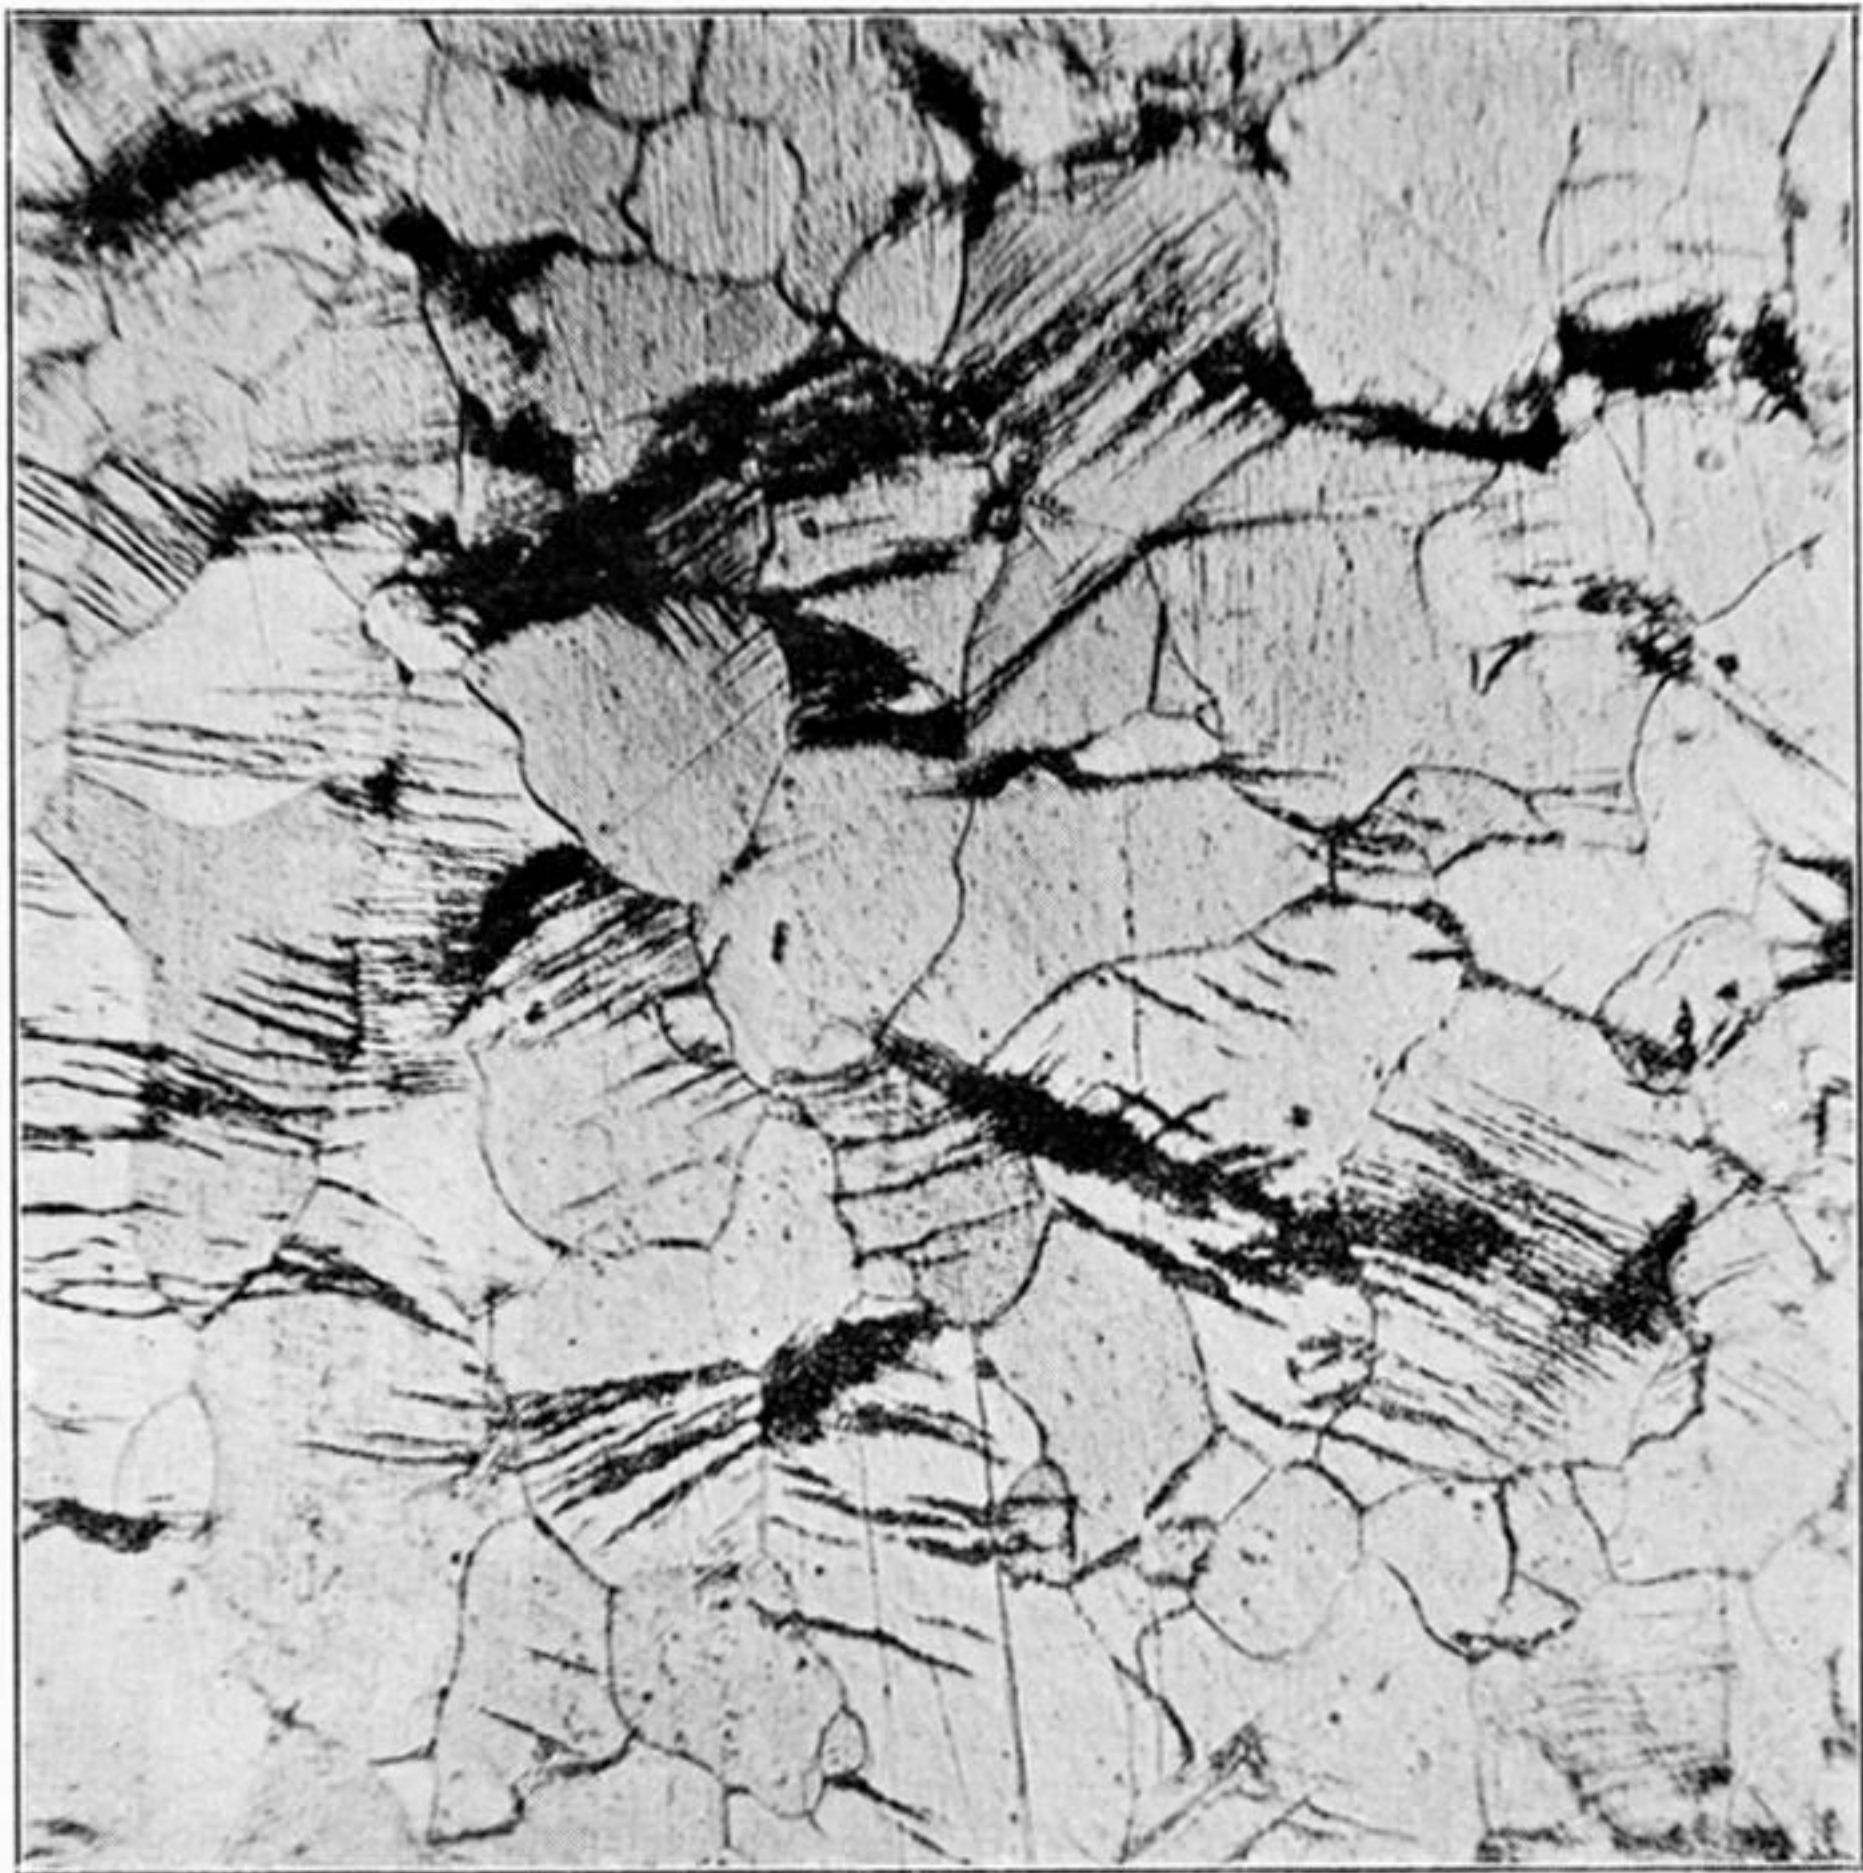
Fig. 4. Same after 40,000 reversals. $\times 150$.

Fig. 4 after 40,000 reversals.

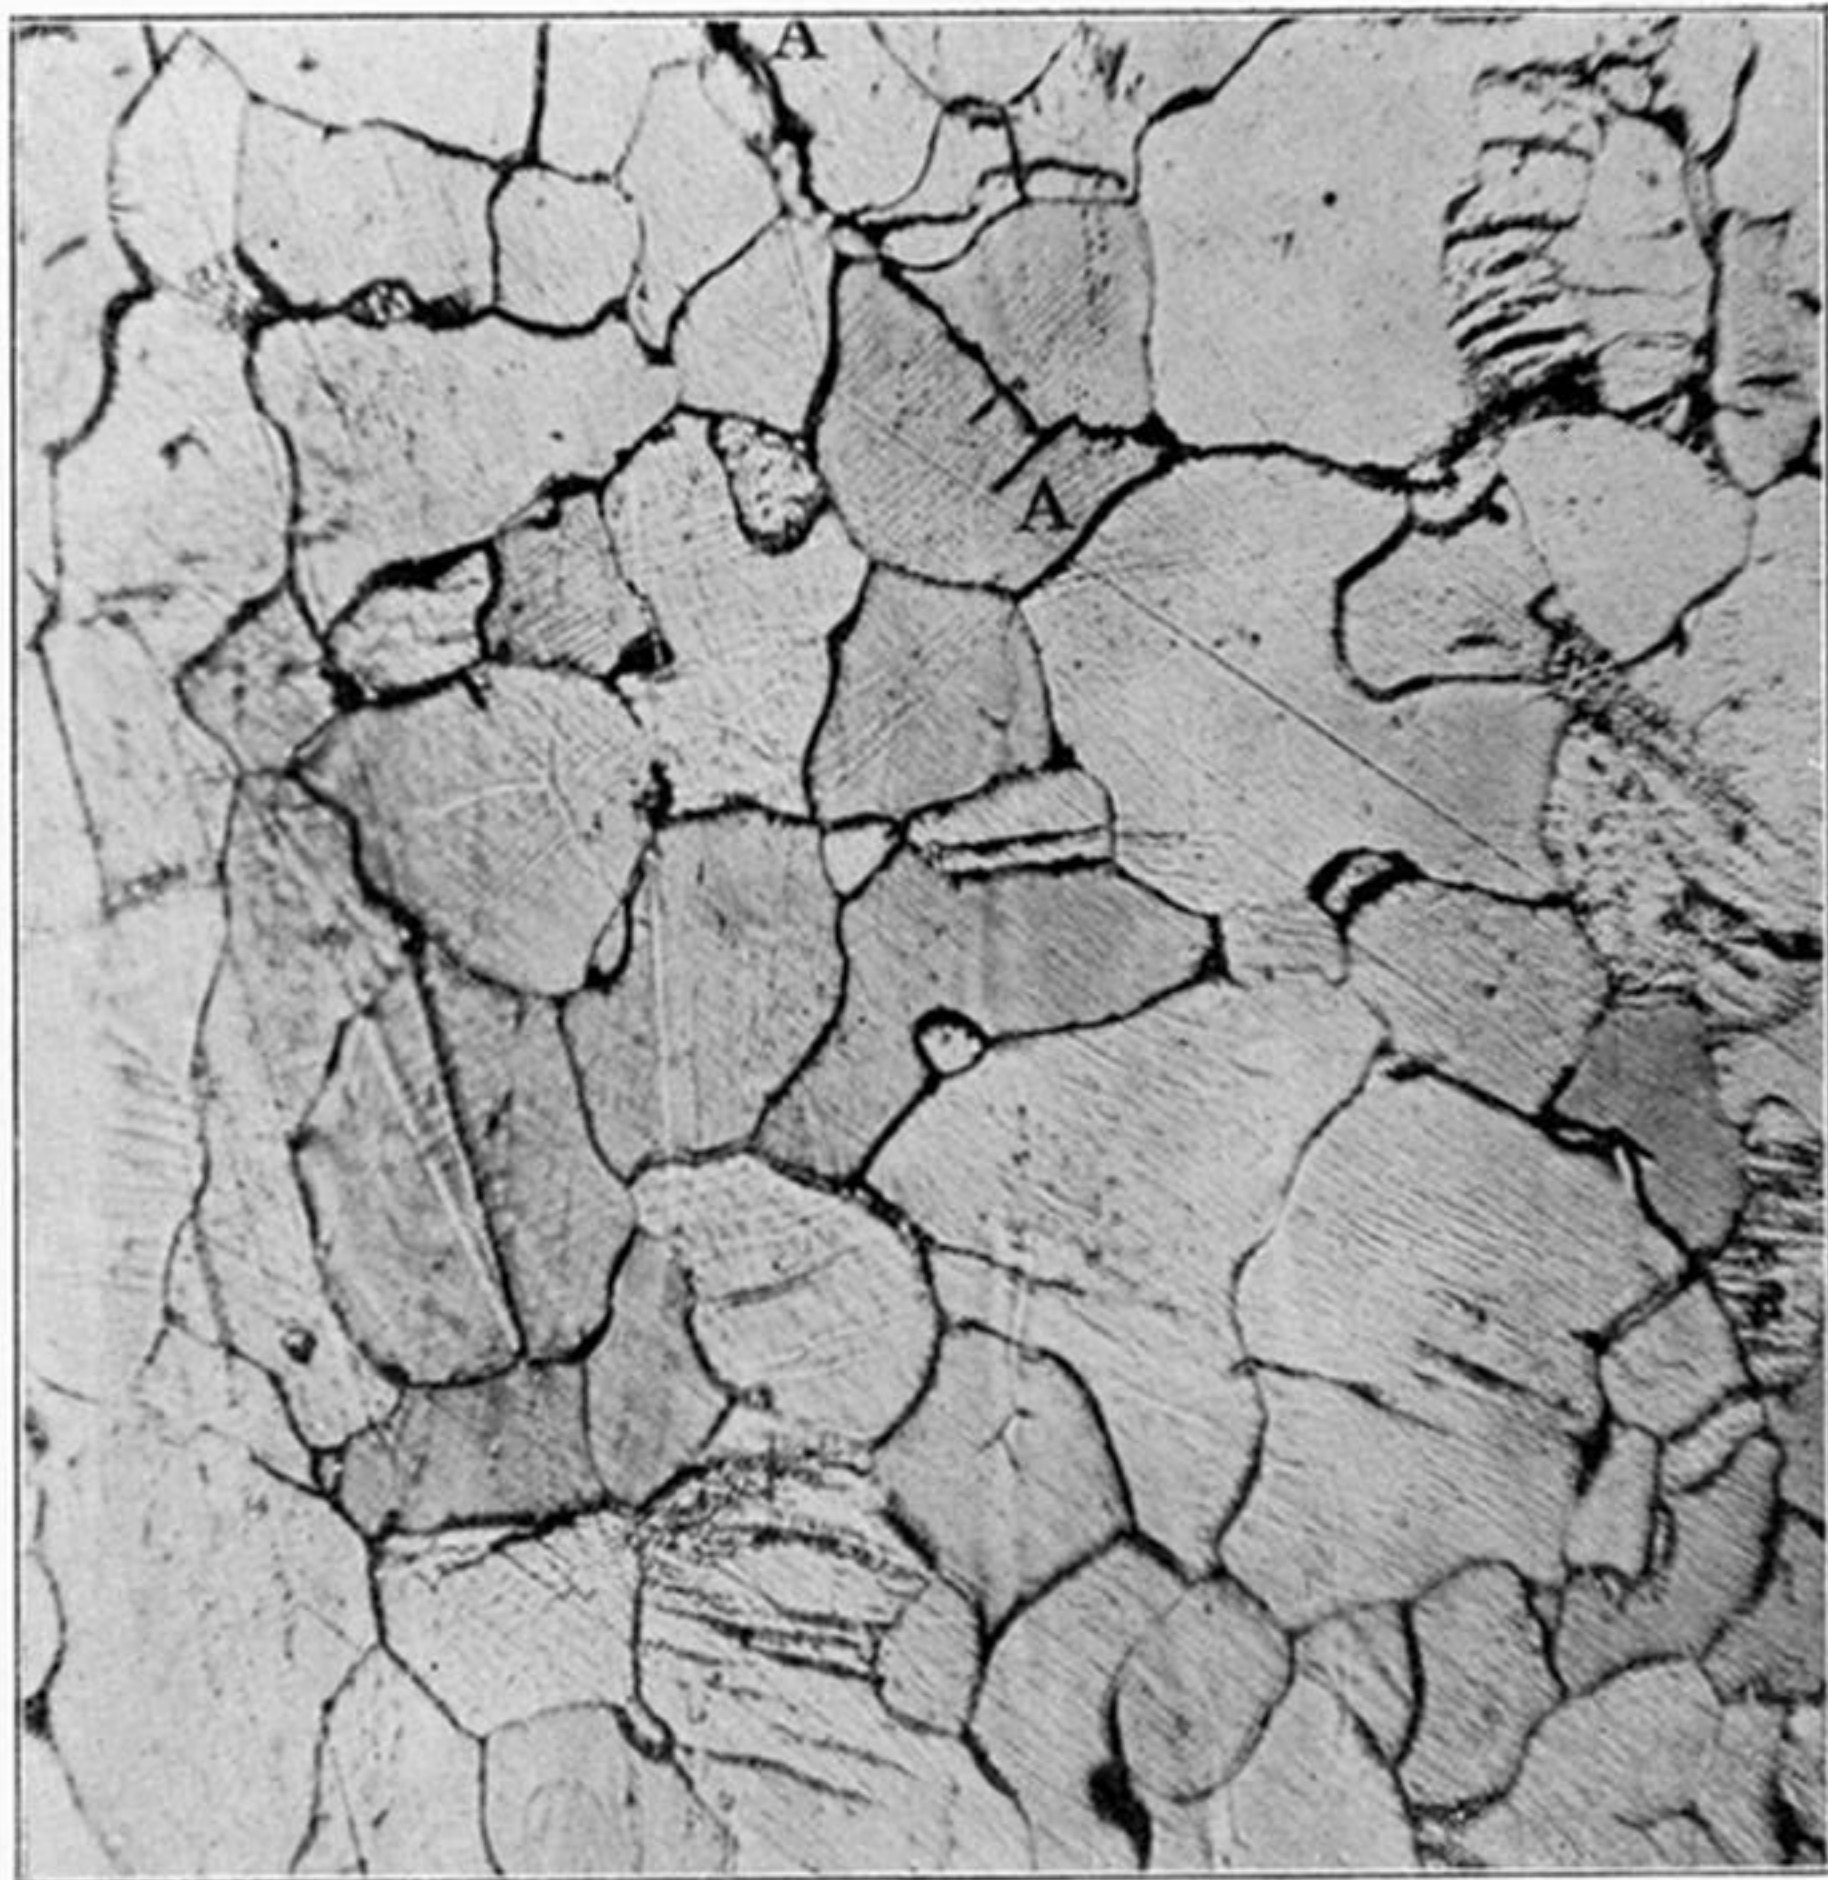
Fig. 6. Same after 70,000 reversals and re-polishing and re-etching. $\times 150$.

When viewed in this state it is not practicable to tell how many of the slip-bands have actually developed into cracks, but this is readily seen when the specimen is re-polished and re-etched. This treatment obliterates any ordinary slip-bands which are steps marking differences of surface level, but any cracks remain visible. The specimen which gave this series of photographs was accordingly re-polished sufficiently to clear away the slip-bands, and was re-etched. This left the cracks alone visible, rather accentuated indeed, for the sides of the cracks are to some extent eaten away by the acid, and hence the width of the crack is increased. Fig. 6 shows the same part of the specimen as figs. 3, 4, and 5, after re-polishing and re-etching. The slip-bands have disappeared, except where they have formed cracks. A careful comparison of this with fig. 3 will show where cracks have formed. The most conspicuous crack is at AA, and its zig-zag character as it follows the two directions of slip-bands across one of the crystals is specially noticeable.

Fig. 6 after 70,000 reversals, followed by re-polishing and re-etching.
