VI. *The Fracture of Metals under Repeated Alternations of Stress.*

By J. A. EWING, LL.D., F.R.S., *Professor of Mechanism and Applied Mechanics in the University of Cambridge*, and J. C. W. HUMFREY, B.A., *St. John's College, Cambridge*, 1851 *Exhibition Research Scholar, University College, Liverpool*.

Received August 11,—Read November 20, 1902.

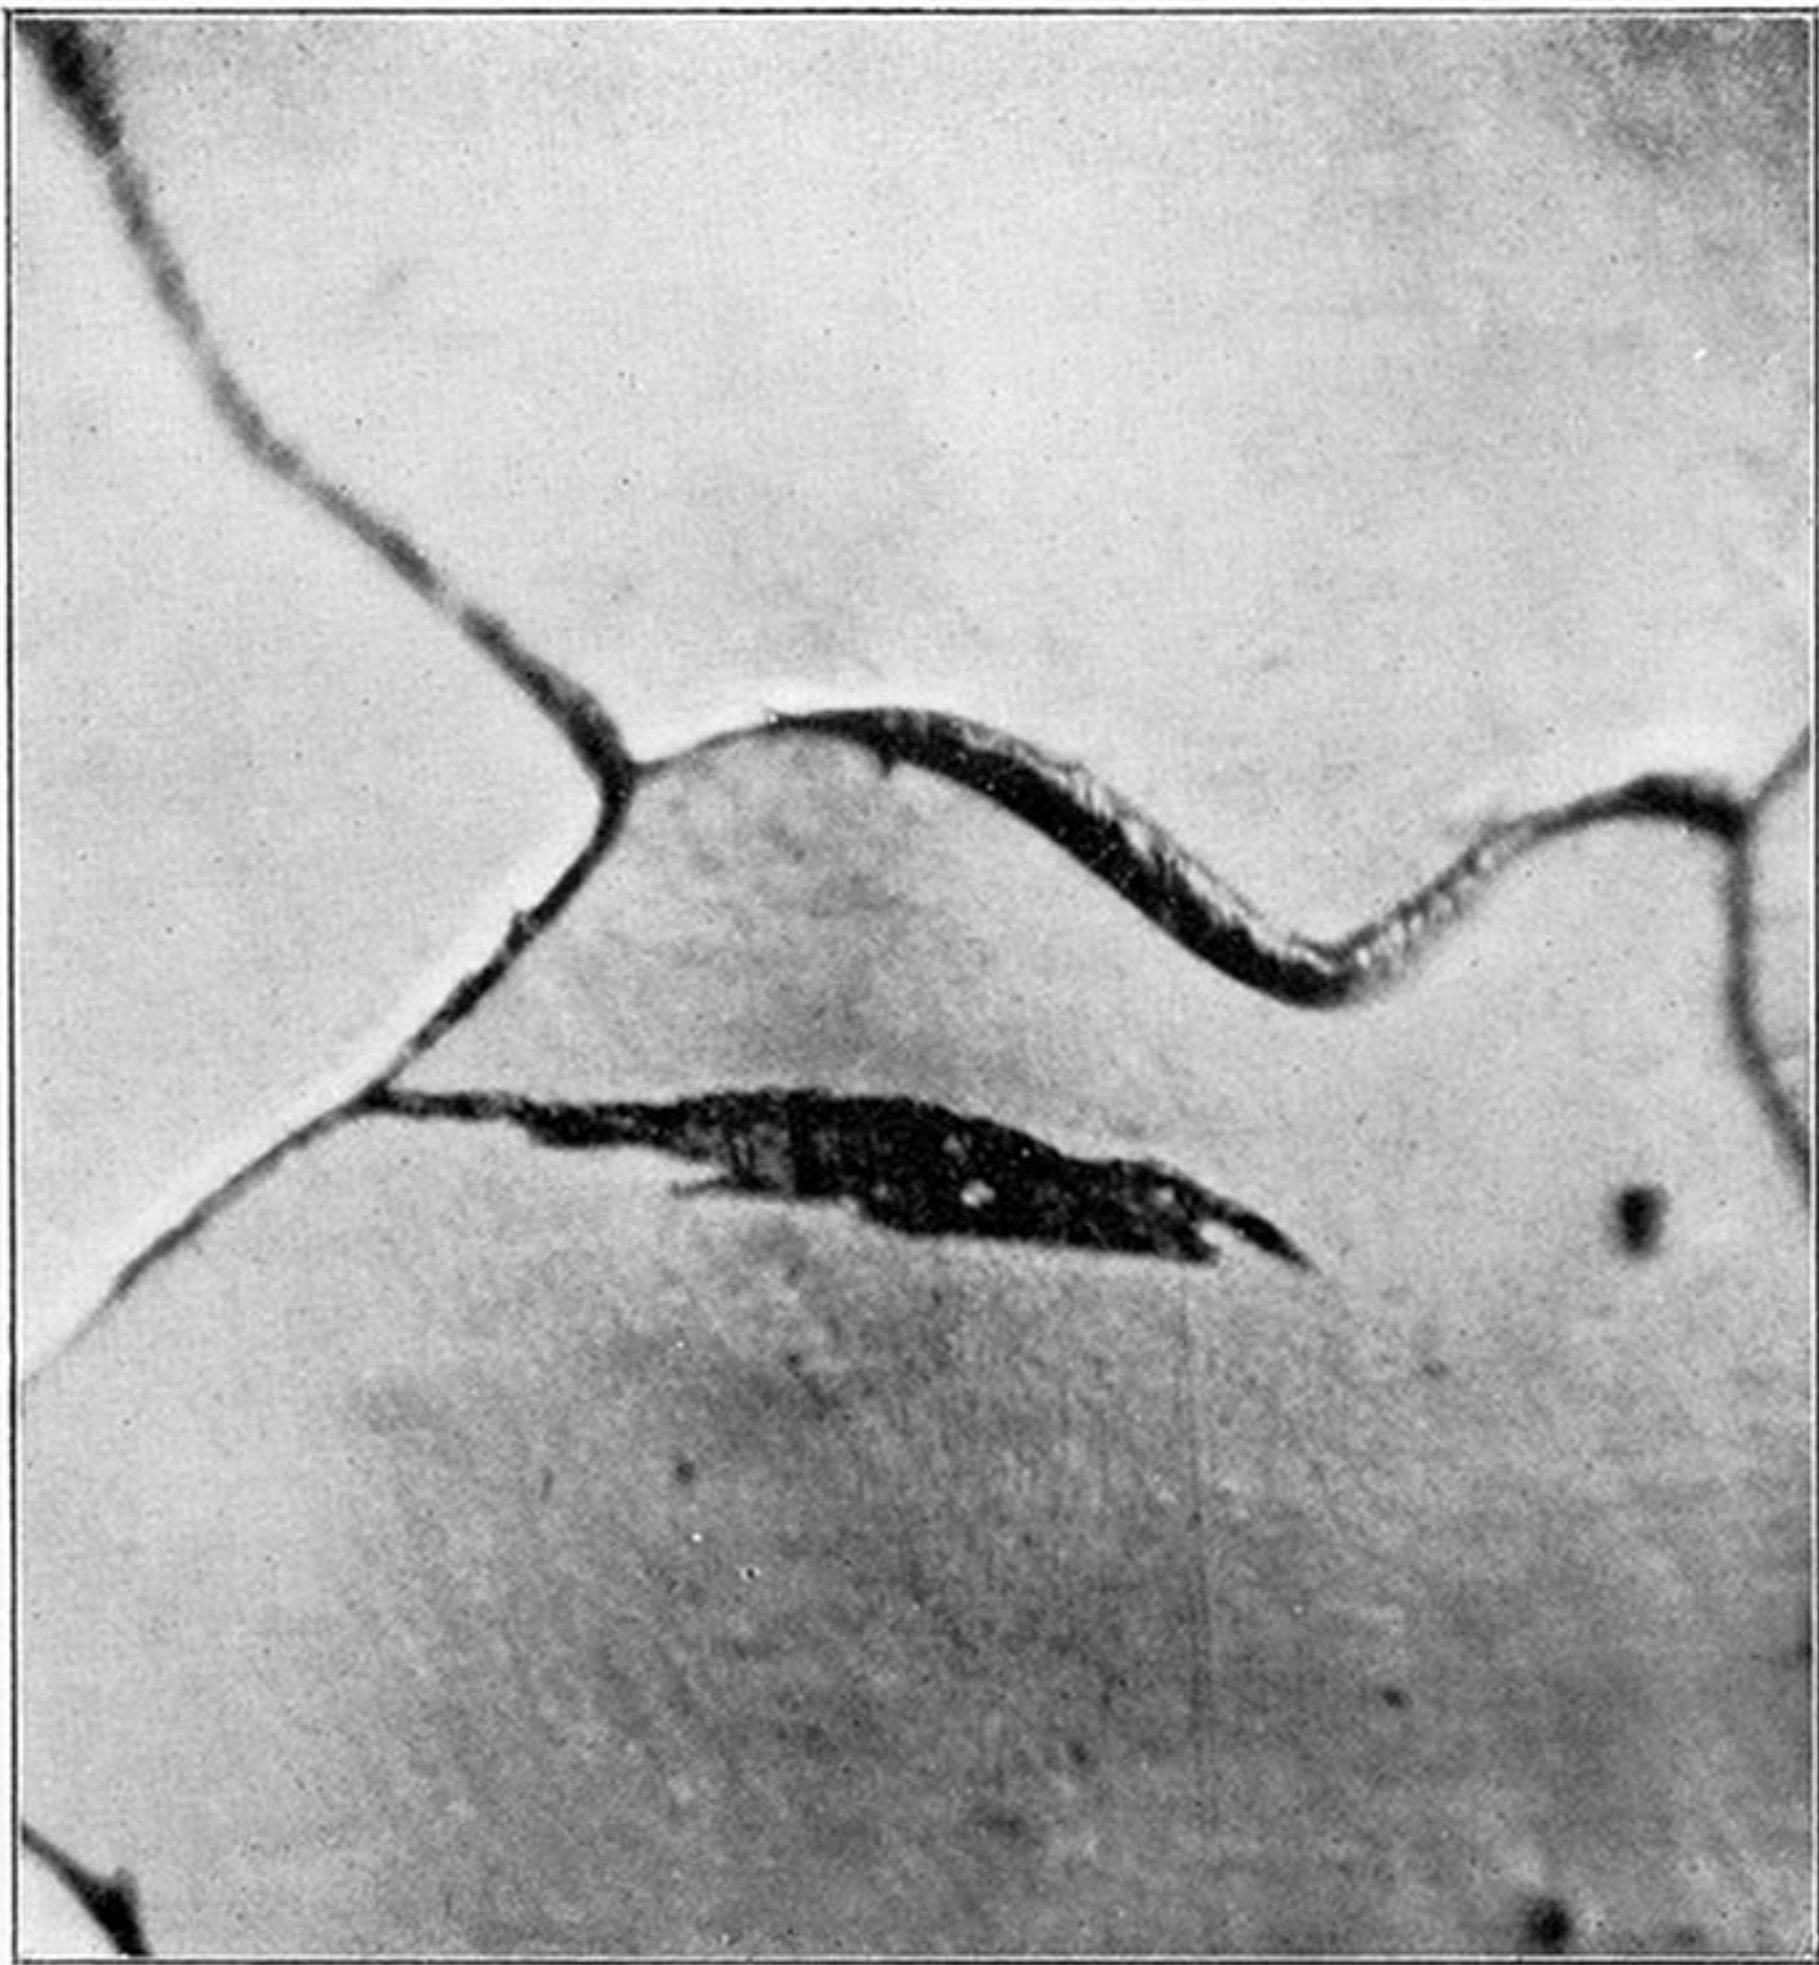
Fig. 15. Specimen after 3,000,000 reversals of a stress of 6.9 tons per sq. inch. $\times 1000$.

Fig. 15. Specimen after 3,000,000 reversals of a stress of 6·9 tons per sq. inch. $\times 1000$.

This was confirmed by another experiment in which the maximum stress, close to the clamp, was only 6.9 tons per sq. inch. After 3,000,000 reversals of this stress *one* slip-band was observed on a crystal a little way from the clamp. This is shown in fig. 15, where the slip-band is seen in the broadened condition which resulted from 3,000,000 reversals of stress. Prior to this, the same specimen had suffered 1,000,000 reversals of a stress of 5.3 tons per sq. inch, without showing the smallest sign of damage. It was only after increasing the stress to 6.9 tons per sq. inch that any action became apparent. It is an open question whether an isolated slip-band such as this would have led to fracture, if the process of reversal had been continued. At the conclusion of the experiment it was still confined to one crystal and it did not even extend all the way across that.

Fig. 15. Development of a slip-band by 3,000,000 reversals of a stress of 6·9 tons per sq. inch.

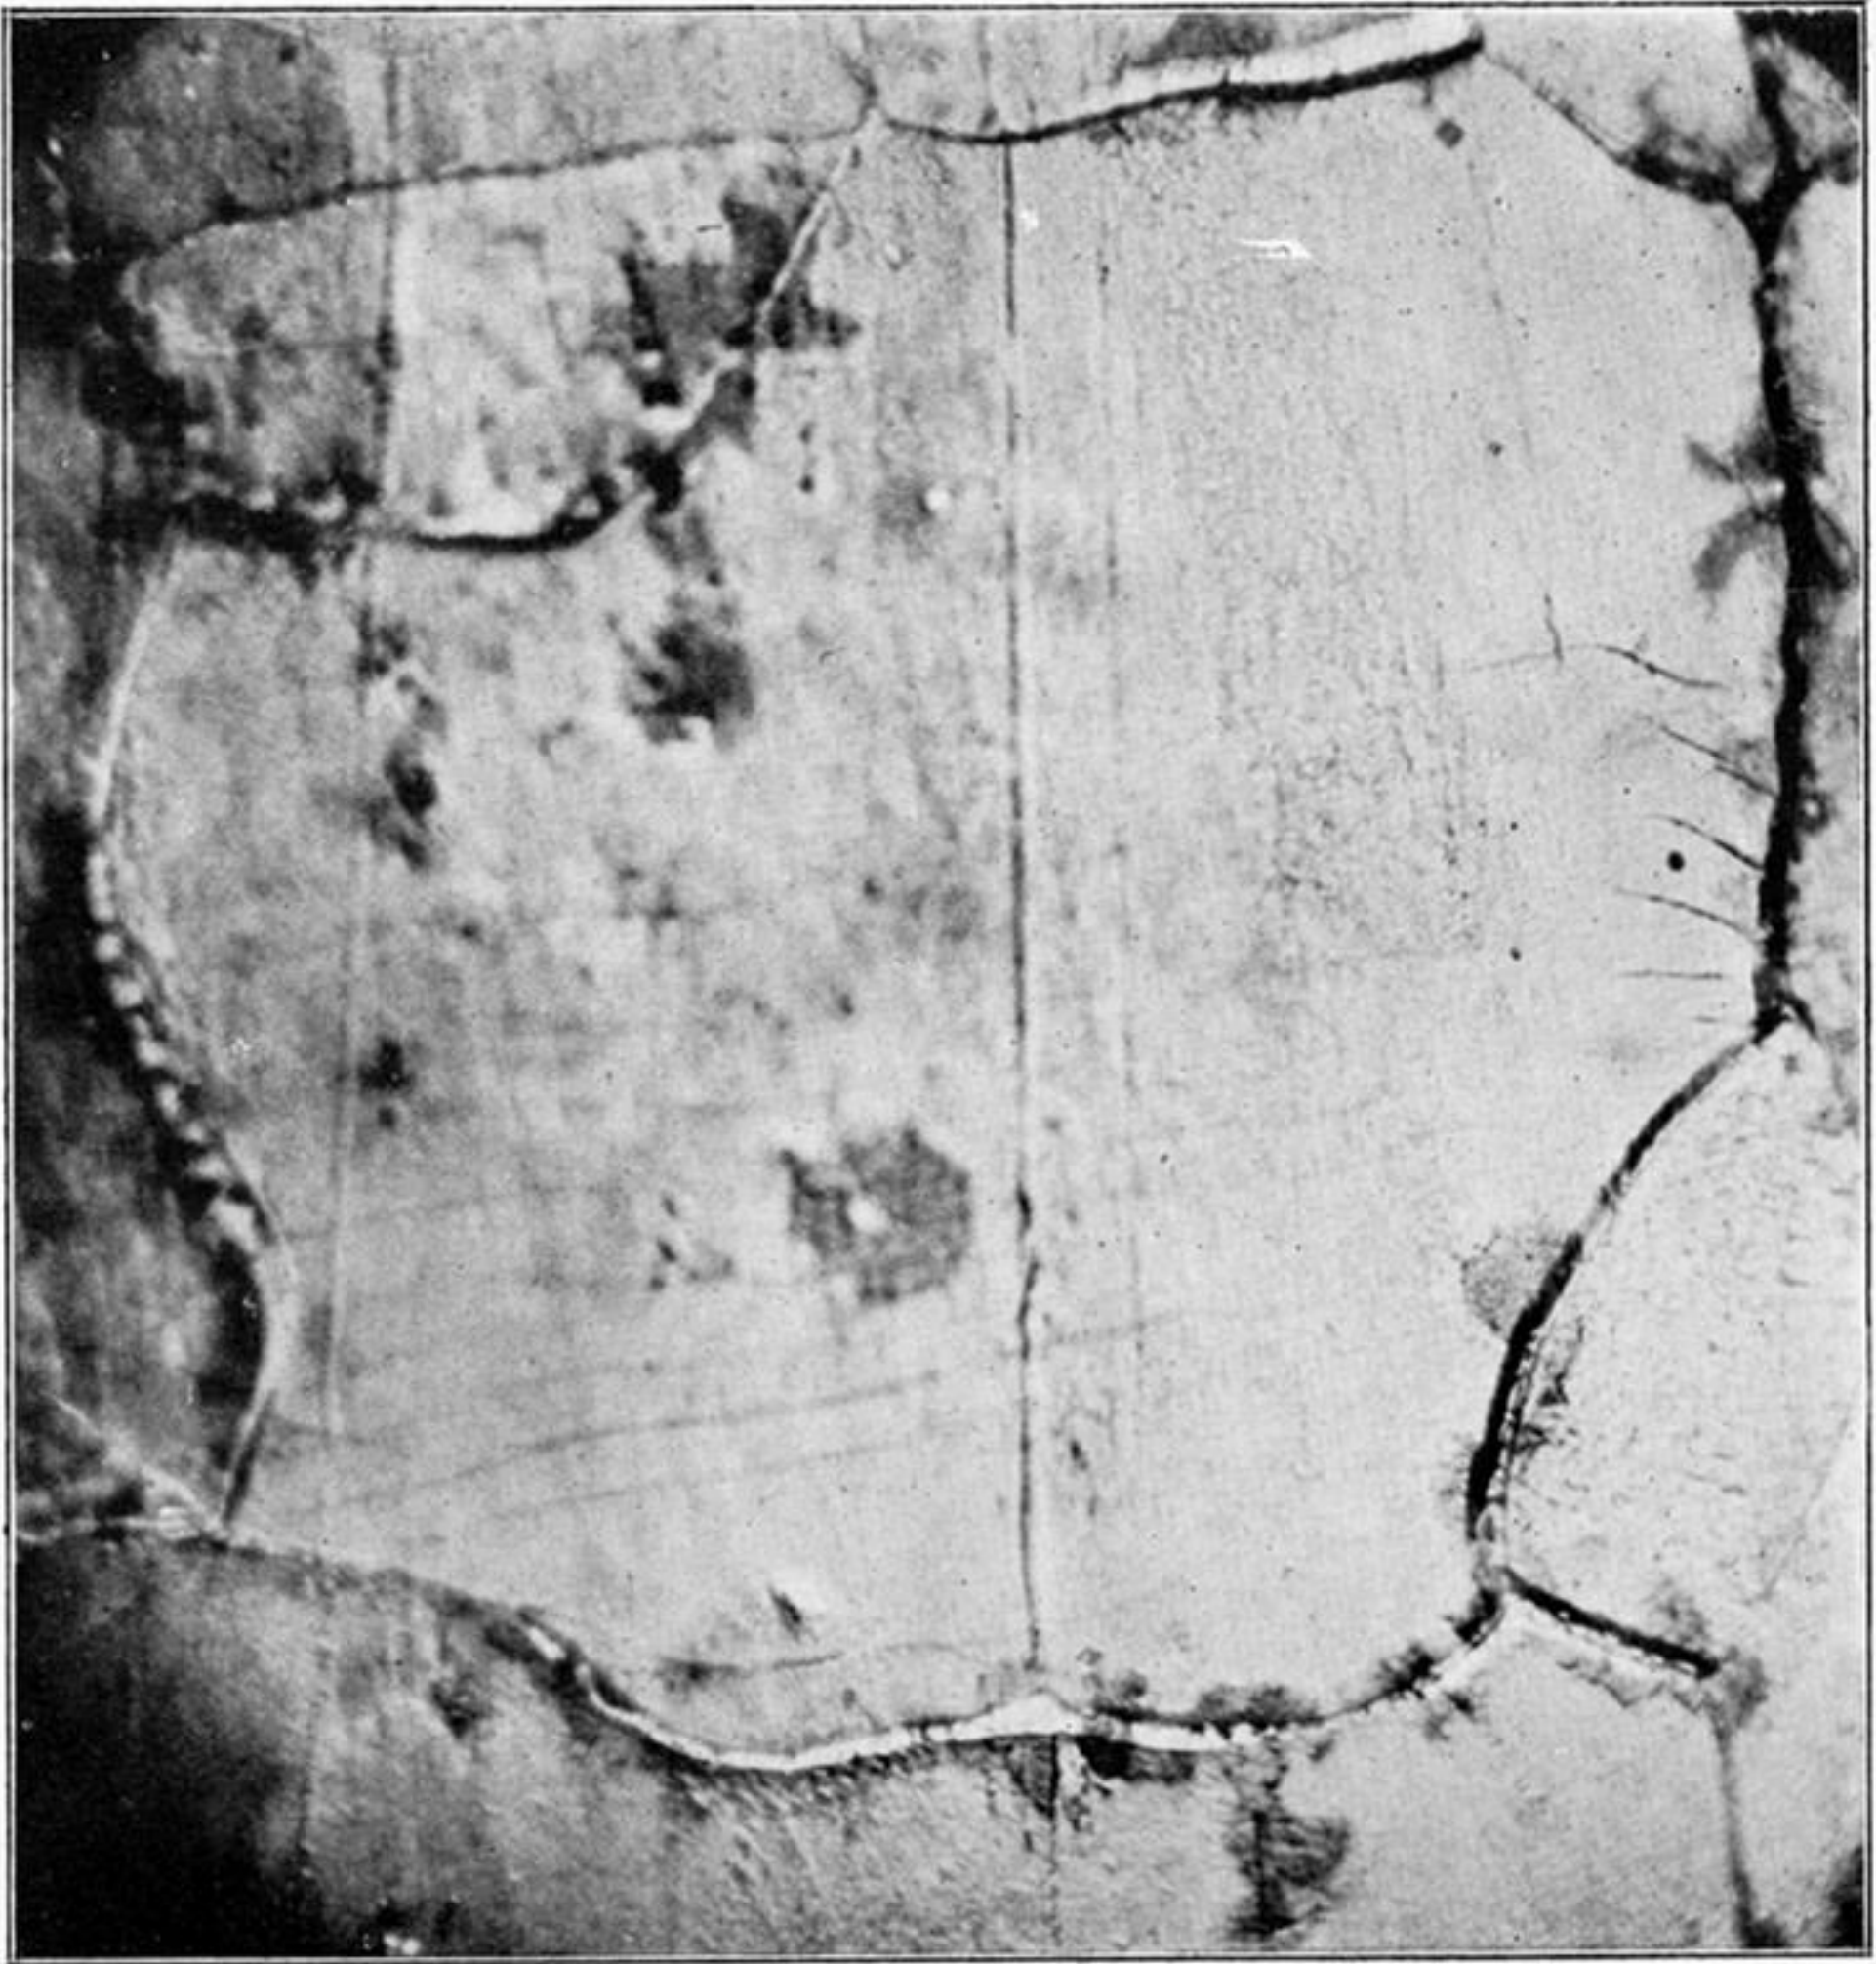
Fig. 10. Same after 2000 reversals. $\times 1000$.

The photographs described above are on rather too small a scale for the actual changes in the slip-lines themselves to be clearly seen, and these are better illustrated by the next series, figs. 9–12. These show with a magnification of 1000 diameters a small part of the surface of another specimen of the same iron which was subjected to reversals of 12.4 tons per sq. inch. Fig. 9 is taken after 1000 reversals. The slip-bands which have formed are very faintly visible as fine lines upon the surface of the crystal. Fig. 10 is after 2000 reversals; the slip-bands seen in fig. 9 are now more distinct, and some new ones on the right of the crystal are fairly strongly defined. Fig. 11 is after 10,000 reversals; some of the slip-bands now show a decided tendency to broaden out and those upon the right have extended further across the crystal. Fig. 12, taken after 40,000 reversals of stress, shows further broadening out and spreading of the

Fig. 10 after 2,000 reversals.
