XLI. *An Account of the Effects of Lightning in St. Bride's Church, Fleet-street, on the 18th of June 1764: In a Letter to Mr. Benjamin Wilſon, F. R. S. from Edward Delaval Eſq; F. R. S.*

Read June 28, 1764. **T**HE incloſed is an account of the effects of the lightning on the ſteeple and ſpire of St. Bride's church, with drawings [TAB. XIV. XV.] which very accurately expreſs the parts damaged by it.

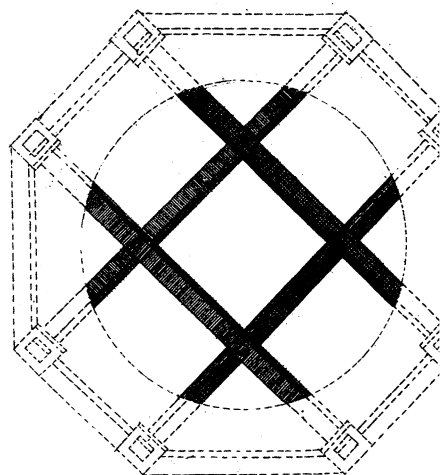
Fig. 2.

At Fig 2, a bar of iron, which served to support the top of the window in the same manner as those last mentioned, 21 inches long clear of the stonework, and half an inch thick, is broke and bent into the position expressed in the drawing; and the stones immediately above it are shattered and disjointed.
